Determination of Area in need of Redevelopment

EMERSON REDEVELOPMENT AREA BOROUGH OF EMERSON, NEW JERSEY

Borough of Emerson
Redevelopment Area - November 2016

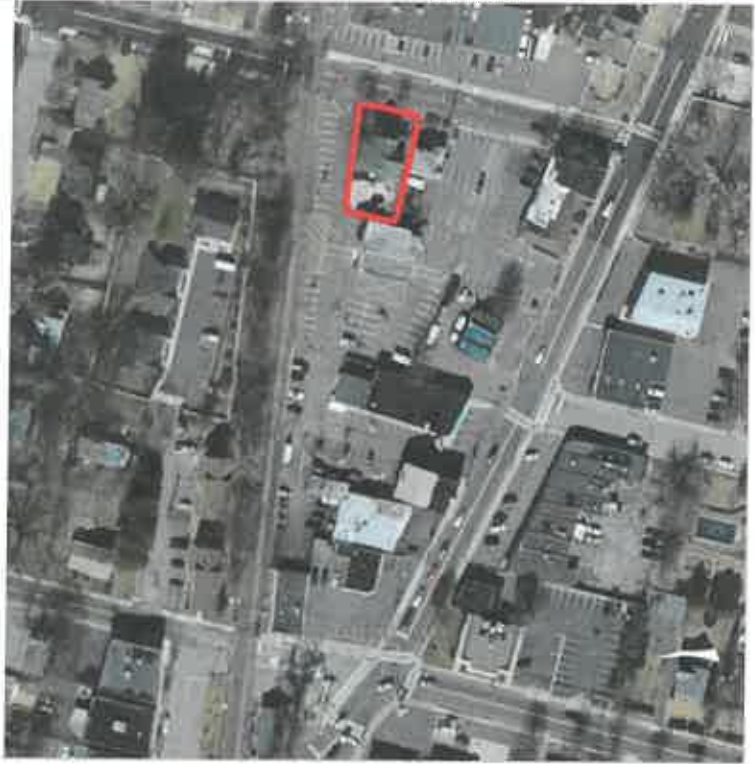
BLOCK 419 LOT 1

Site Inspection Observations: Currently, on this site is a two-story residence. The building is situated on an undersized lot without parking. The building is in a substandard, unsafe and deteriorated condition as can be seen in the photographs below. The roof has holes in it and is caving in, the siding has numerous holes, the windows are deteriorating exhibiting water damage, and the gutters are falling down. The building is in a state of disrepair.

1. **Deterioration.** The dwelling is in a dilapidated condition as it has a crumbling roof and siding, holes in the walls, damaged gutters, deteriorated porch floor and crumbling windows, which is unsafe and substandard for occupancy. Therefore, this property is consistent with Criteria "a".

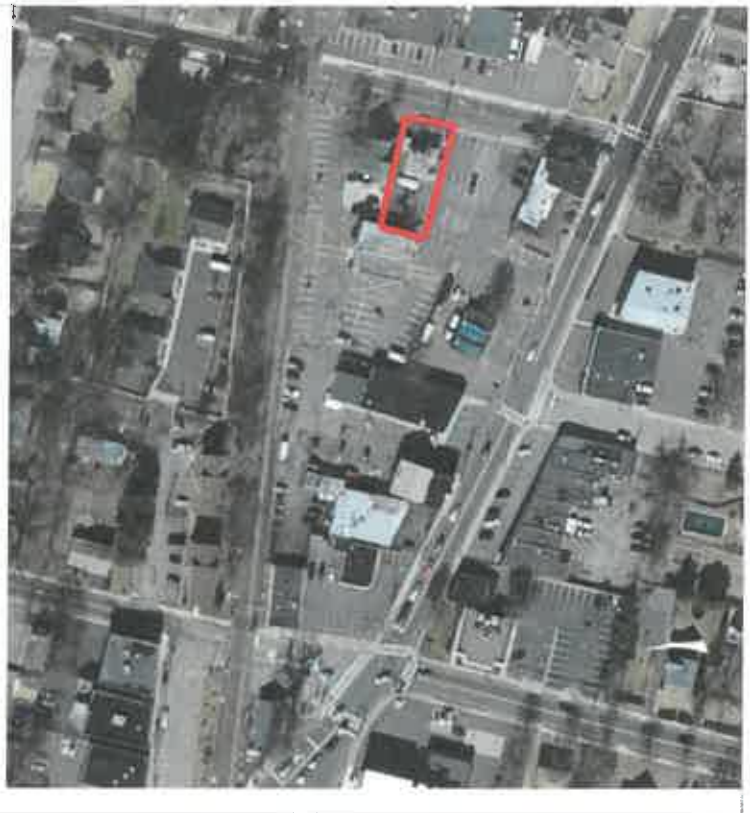
BLOCK 419 LOT 2

Description: Vacant Lot was Residential

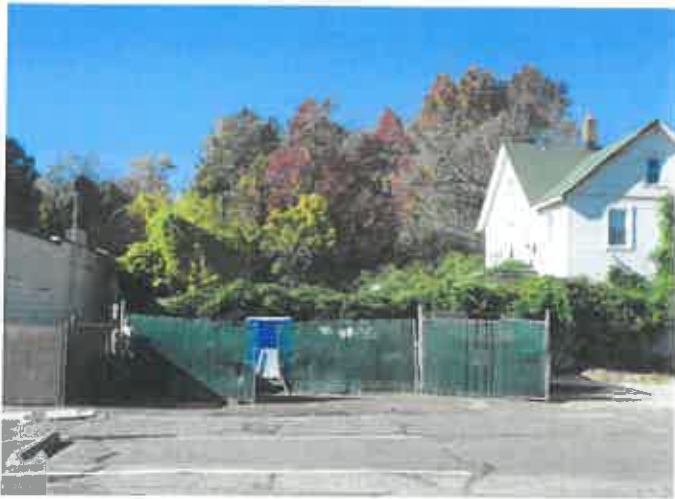
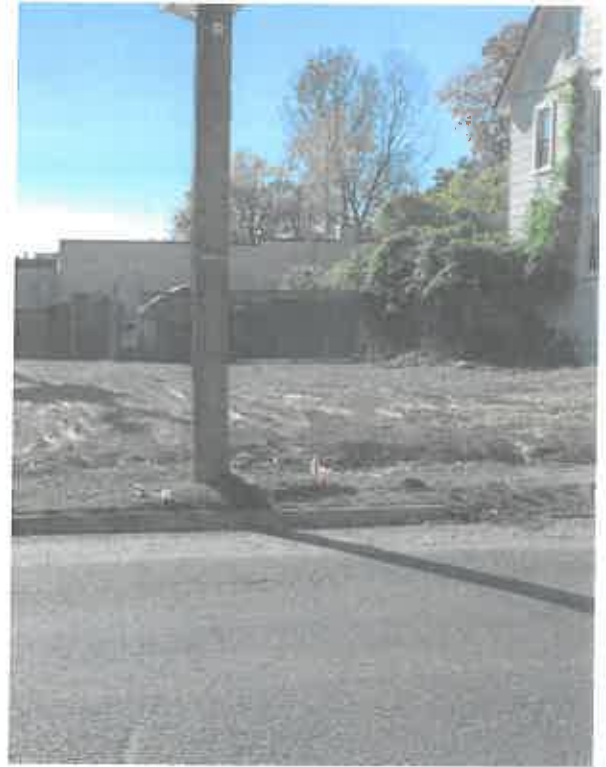
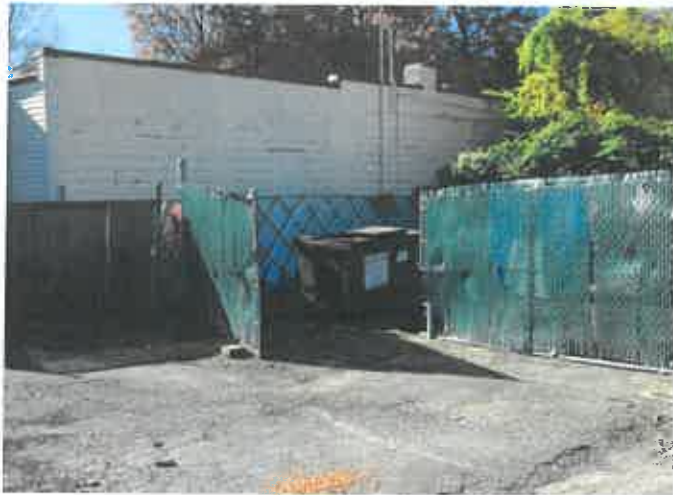
Evaluation: Site is considered substandard for the following reasons: It was a nonconforming residential land use that was demolished. This site is currently vacant and has been for several years. Its improvement to land value ratio is only 0.045 wherein the standard for property utilization of land is a ratio of 2.0. As such it represents a significantly underutilized property in the heart of the Borough's Central Business District and Redevelopment Area. It is not developed, nor has it ever been developed consistent with the goals and objectives of the Master Plan and Central Business District Plans as detailed in this report. The property exhibits conditions consistent with Statutory Criteria "e". This was confirmed through site inspections, as can be seen in the photographs above. In this investigation, the analysis for criteria "e" has focused both on the underutilization of the stagnant area but also the broader land use and planning goals of the municipality. It has concluded that the area as a whole is not developing in a manner that furthers or is consistent with the Borough's land use plan and the proximity to the train station which offers excellent opportunities for smart growth and transit-oriented development. In addition, given its location, this property is necessary to the effective redevelopment of the entire area.

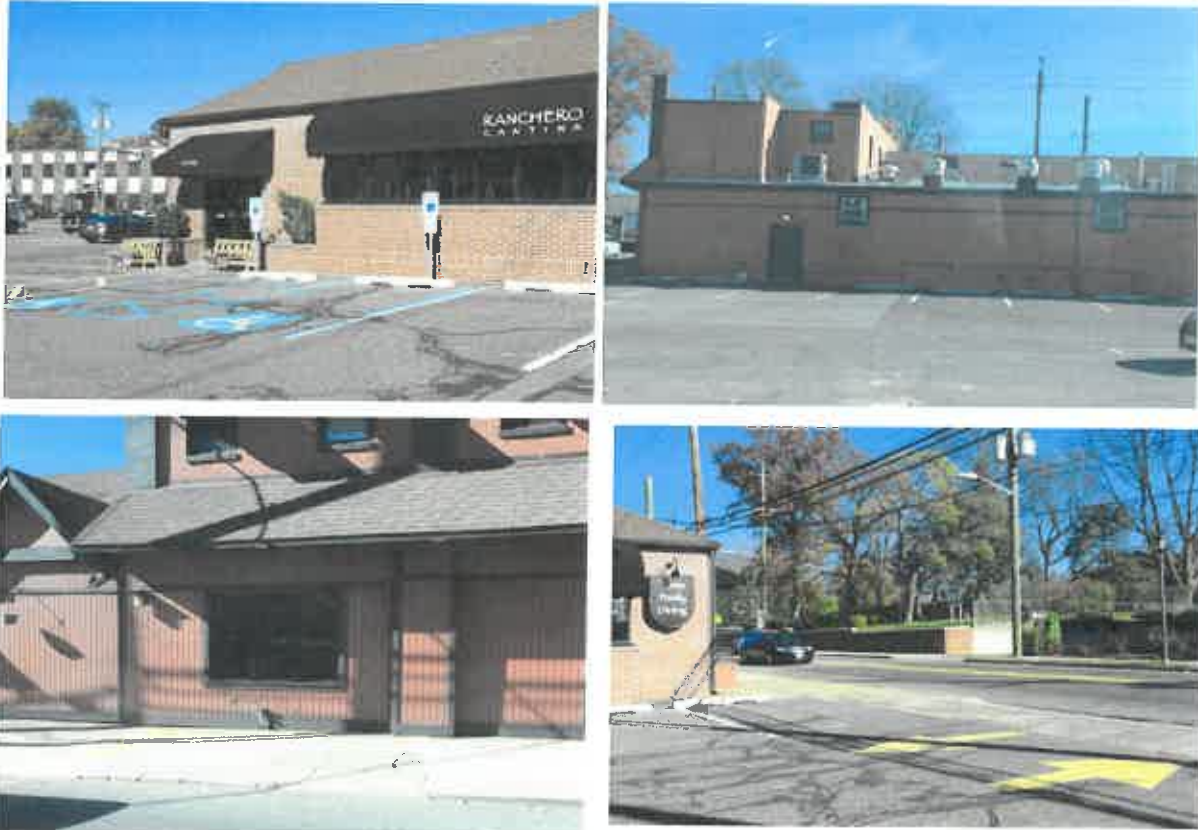
BLOCK 419 LOTS 3 & 4

Site Inspection Observations: one-story restaurant with excess lot coverage, insufficient surface parking and unsafe vehicular circulation. The building was recently renovated, however the site itself still remains inefficient.

Evaluation: Site is considered substandard for the following reasons: The site exhibits faulty arrangement that is characteristic of meeting Statutory Criteria "d". This is due to the fact that the site was developed as one lot and not as a comprehensive plan. The faulty arrangement is due to the size and use of the building on site. This creates a site with an inefficient layout and lack of parking which creates a greater demand for on-street parking, thereby having a negative impact on surrounding properties and the area. In this investigation, the analysis has focused on the broader land use and planning goals of the municipality. It has concluded that the area as a whole is not developing in a manner that furthers or is consistent with the Borough's land use plan and the proximity to the train station which offers excellent opportunities for smart growth and transit-oriented development. Further, Section 3 of the LRHL (N.J.S.A 40A:12A-3) allows the inclusion of parcels necessary for the effective redevelopment of the area, by stating "a redevelopment area may include land, buildings or improvements, which of themselves are not detrimental to the health, safety, or welfare, but the inclusion of which is found necessary, with or without change in their conditions, for the effective redevelopment of the area in which they are a part. The property exhibits some conditions consistent with Statutory Criteria "d". which creates a greater demand for on-street parking, thereby having a negative impact on surrounding properties.

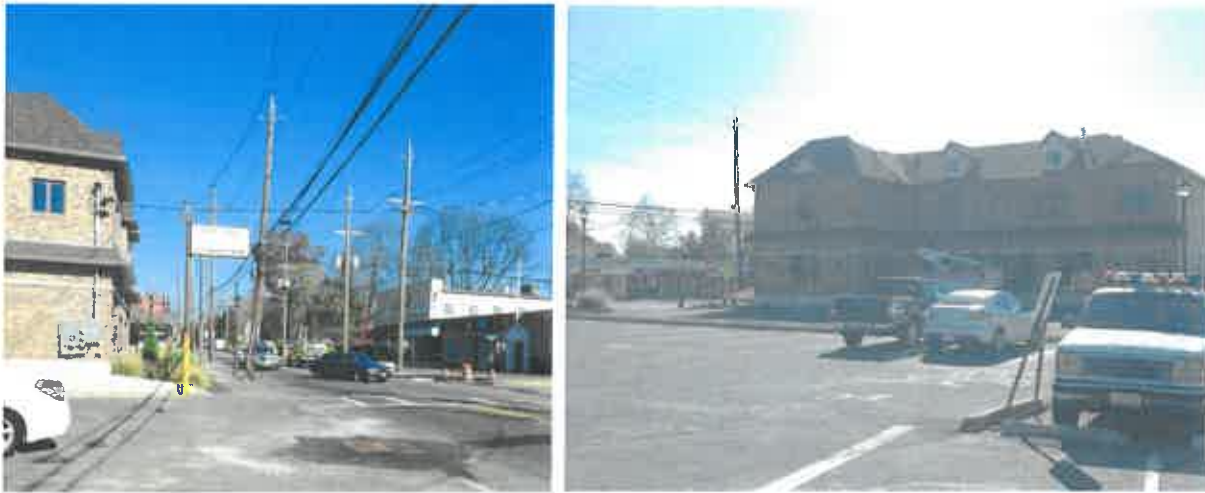
Site Inspection Observations: This site was previously an abandoned one-story structure, in deteriorating condition with roof and façade repairs needed and site maintenance lacking with weeds and debris. It has since been redeveloped.

1. The site exhibits faulty arrangement that is characteristic of meeting Criteria "d". However this is due to the fact that the site was redeveloped as one lot and not as a comprehensive plan. The faulty arrangement is due to the size and location of the building on site. This creates a site with an inefficient layout, however there is an opportunity to improve the circulation on and off site and improve the parking design. This can be done by cross circulation easements to adjacent parcels and with keeping all the improvements in tact and in a manner consistent with the redevelopment plan goals and objectives.

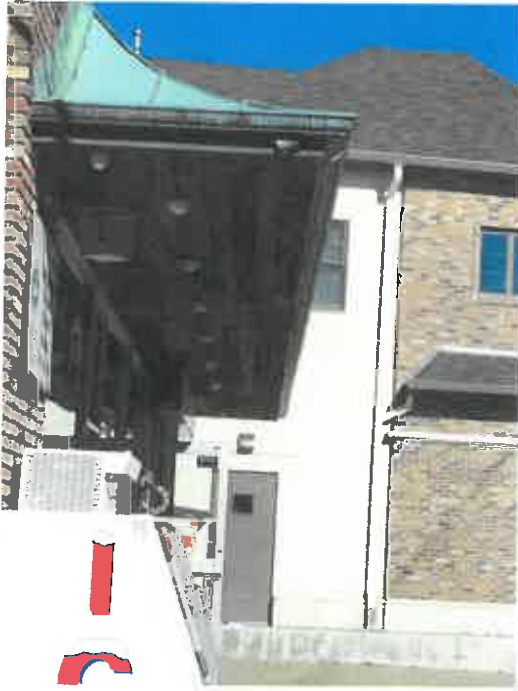
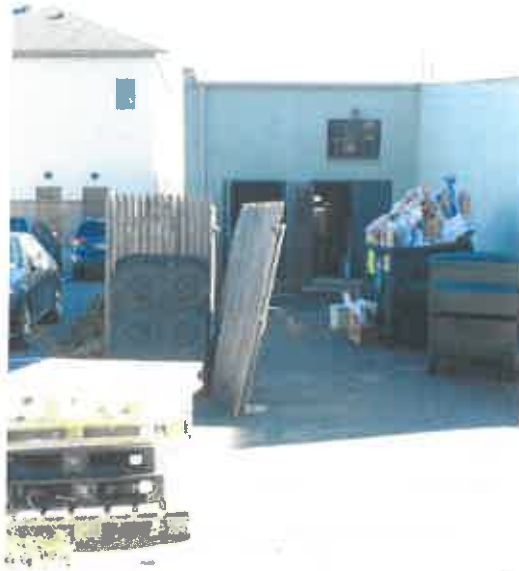
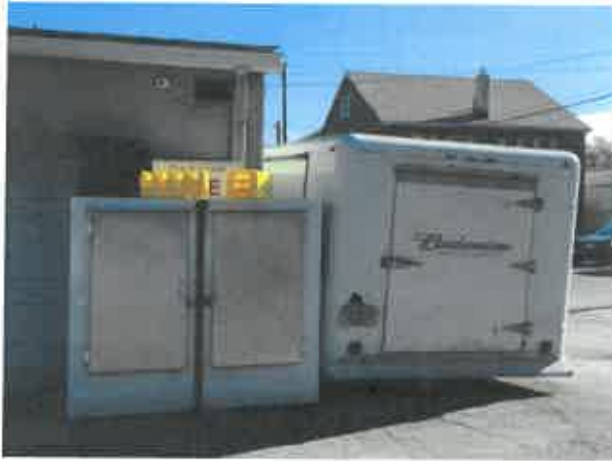
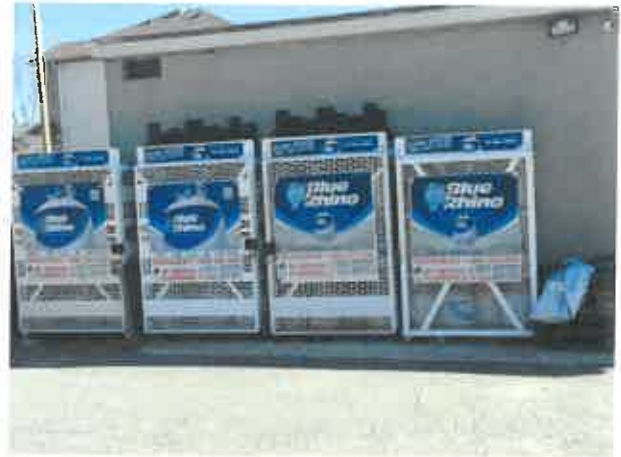
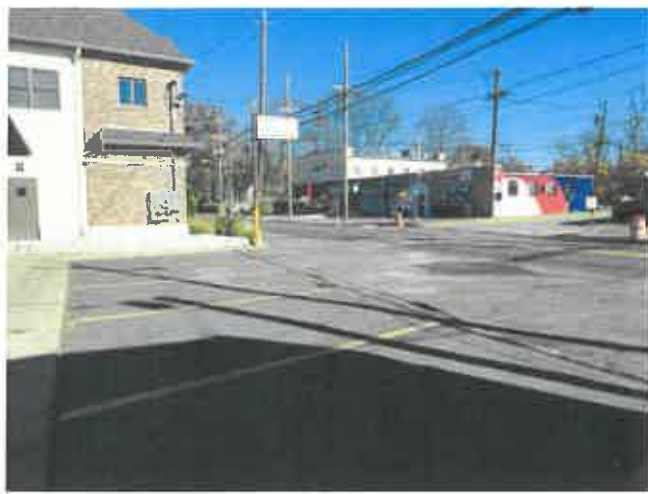
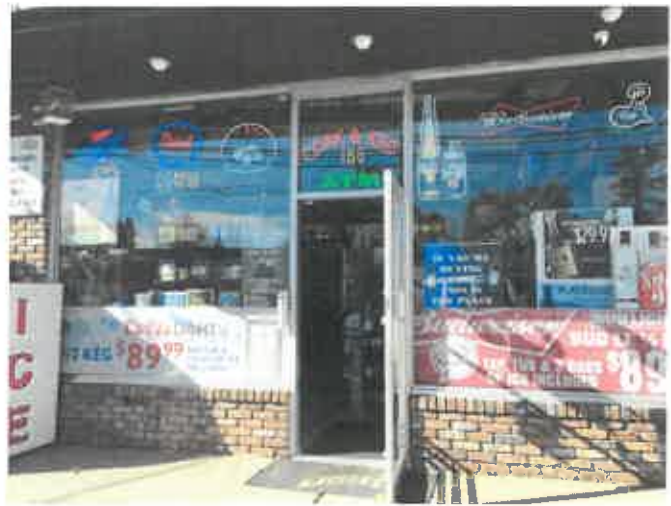
BLOCK 419 LOT 6.01

Site Inspection Observations: one-story structure with liquor store and cleaner. The site is not undersized for the zone, however the current building/uses create the need for outdoor storage of materials adjacent to vehicle circulation aisles. The site in general has unsafe vehicular circulation resulting from undefined curb cut, and parking spaces that allow a vehicle to back directly onto Kinderkamack Road, excess signage, unmaintained parking lot with potholes

1. The site exhibits faulty arrangement that is characteristic of meeting Statutory Criteria "d". The Faulty arrangement is due to the size and location of the building on site. This creates a site with an inefficient layout with no opportunities to improve. Given the uses and building size, there is a need for outdoor storage and display as can be seen from the photographs. The lack of a curb cut is of typical of modern planning standards.

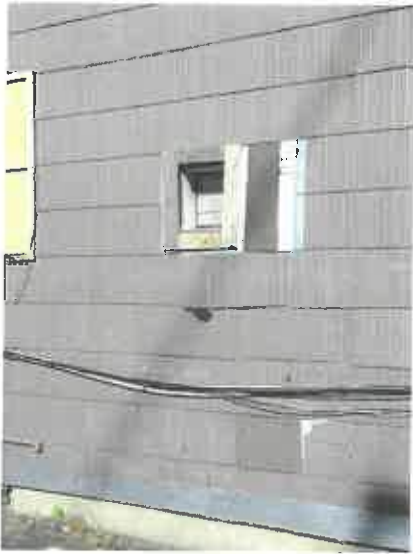
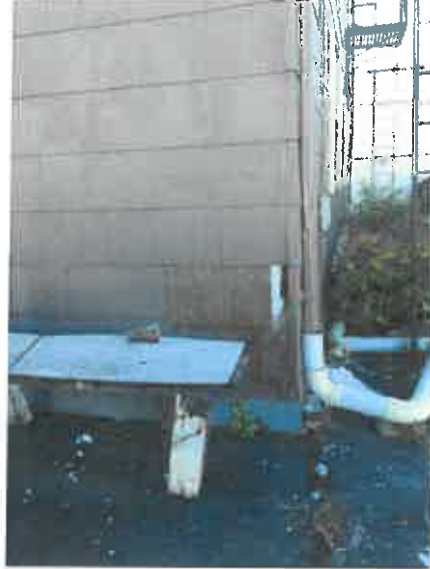
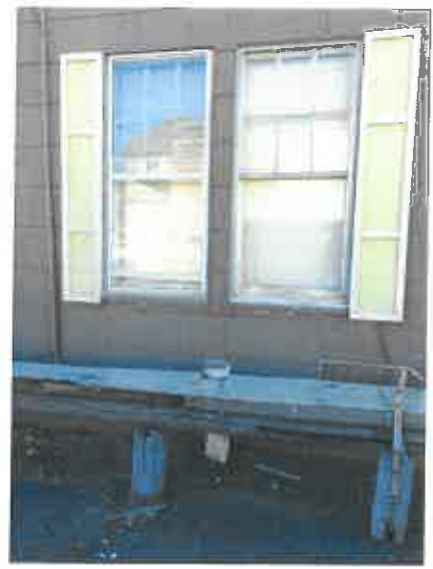
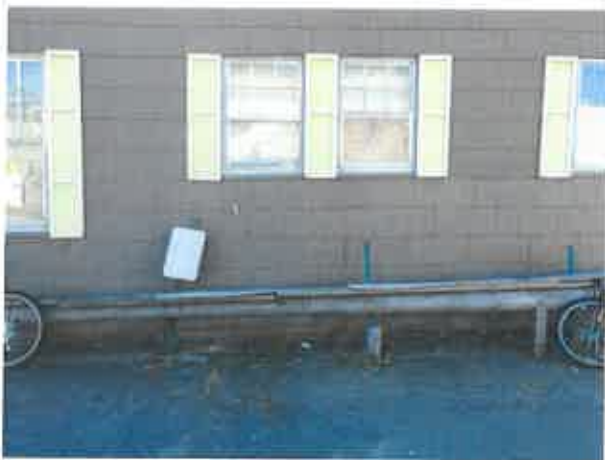
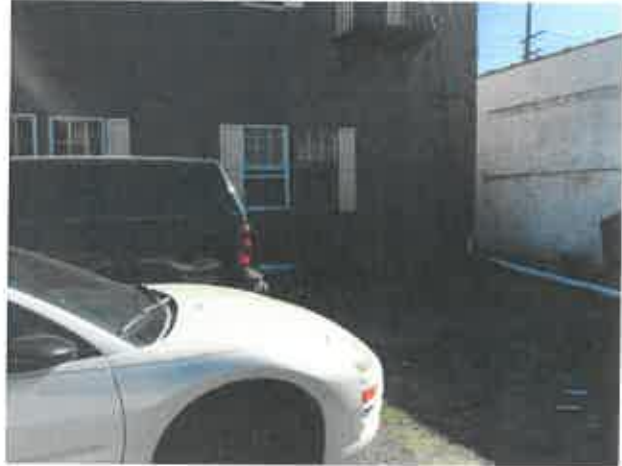
Site Inspection Observations: two-story structure on an undersized lot with ground floor commercial and five residential units above with on-site surface parking. Parking and sidewalk appears to be poorly maintained with un-delineated parking spaces, unpaved areas and potholes, weeds growing through the asphalt and a light pole in the middle of the lot impeding movement. The deteriorating façade has holes in the siding, and boarded up windows. All the windows are covered, with and deteriorating panes. The guardrail adjacent to the circulation aisle is deteriorated to the point it is falling apart.

1. **Deterioration.** The building is dilapidated as evidenced by crumbling siding, holes in the walls, damaged gutters, deteriorated crumbling and boarded up windows. Moreover, the building appears to have not been properly maintained as illustrated in the photographs above. Additionally, the deteriorated and unsafe sidewalk and parking area have negative impacts on the public and surrounding properties by creating a greater demand for on-street parking. As such, Statutory Criteria "a" is met.

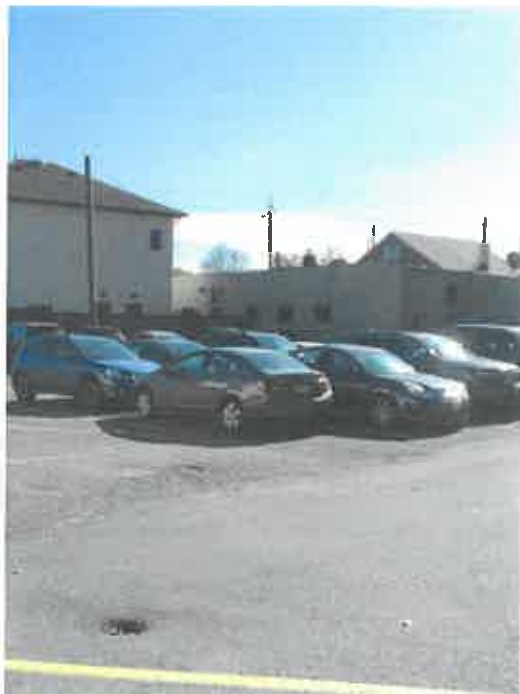
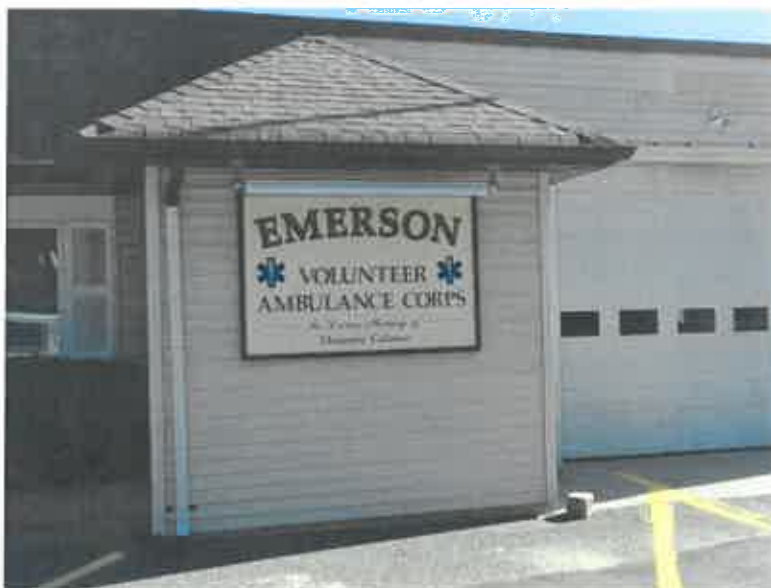
BLOCK 419 LOT 7

Evaluation: Site is considered substandard for the following reasons: This site is currently utilized for surface parking area. The improvement to land value is only 0.27 where a standard of 2.0 is considered appropriate for land. As such it represents an underutilized property in the heart of the Borough's Central Business District and Redevelopment Area. It is not developed, nor was it ever developed consistent with the goals and objectives of the Master Plan and Central Business District Plans as detailed in this report. The property exhibits conditions consistent with Statutory Criteria "e". This confirmed through site inspections, as can be seen in the photographs above. In this investigation, the analysis for criteria "e" has focused both on the underutilization of the area but also the broader land use and planning goals of the municipality. It has concluded that the area as a whole is not developing in a manner that furthers or is consistent with the Borough's land use plan and the proximity to the train station which offers excellent opportunities for smart growth and transit-oriented development.

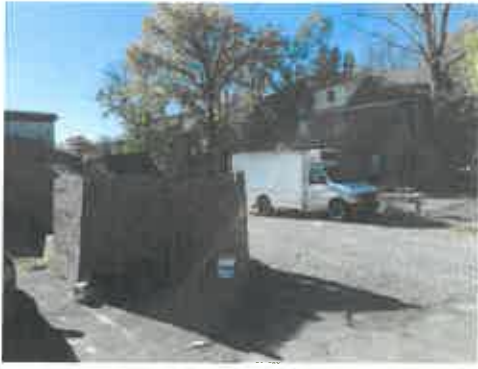
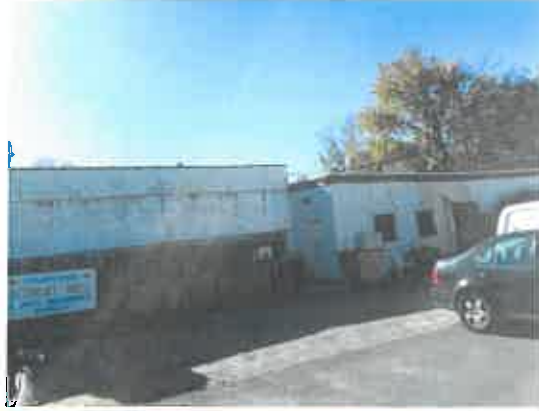
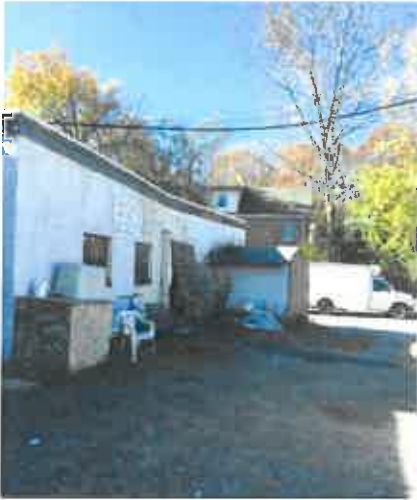
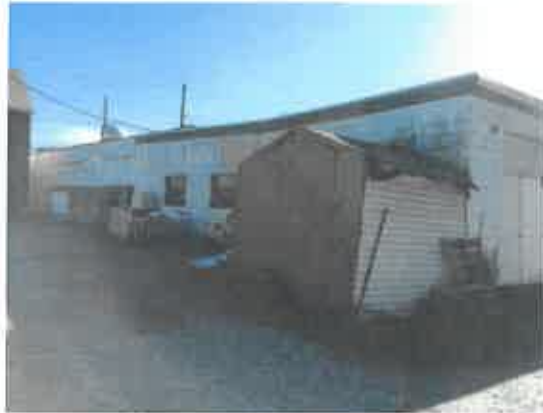
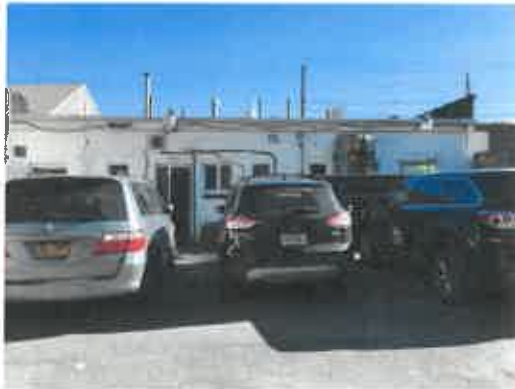
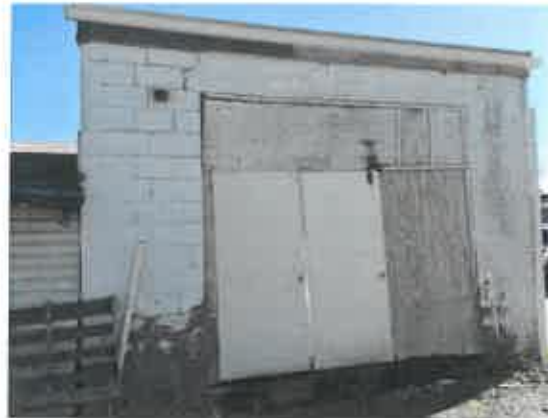
Site Inspection Observations: one-story multi-tenant commercial building with on-site parking that is poorly controlled with a wide curb cut and excess lot coverage. While the front of the building appears to be in adequate condition, the rear of the building is deteriorating.

1. **Deterioration.** The building is dilapidated as evidence by crumbling concrete, holes in the walls, damaged gutters, and deteriorated crumbling windows. The building appears to have not been properly maintained as illustrated in the photographs above. Additionally the deteriorated parking area, and sidewalk have negative impacts on the public. Therefore, Statutory Criteria "a" is met.

2. **Improper layout.** The front of the site has an undefined curb cut, which allows for vehicles to back into Kinderkamack Road. Further the rear of the site has a faulty arrangement due to lacks parking and the proper drive aisles. If the parking spaces are utilized a vehicle has to back out onto the adjacent lot to exit the site thus, creating a negative impact to the adjacent property. Therefore, Statutory Criteria "d" is met.

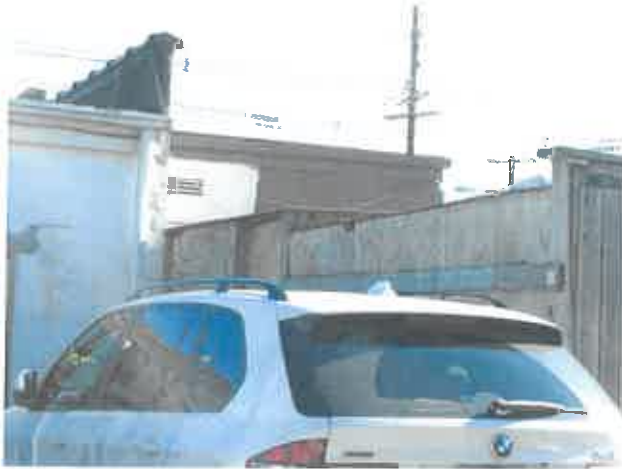
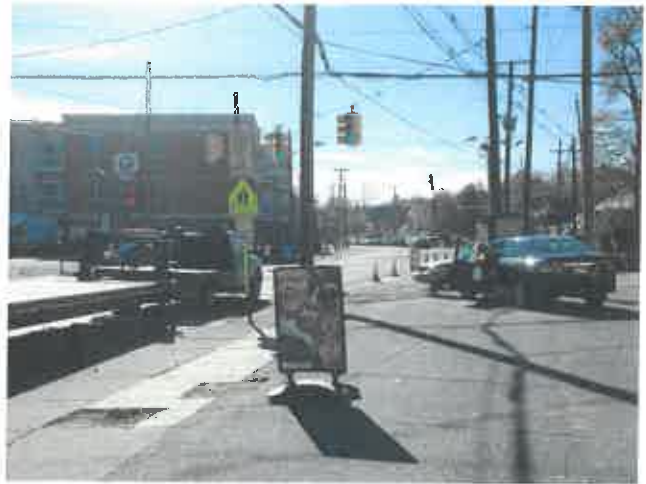
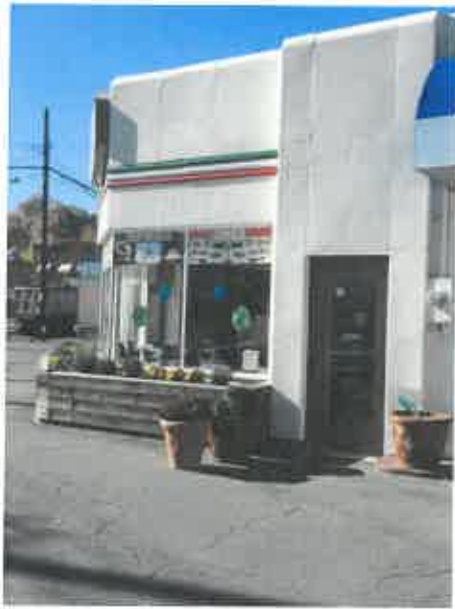
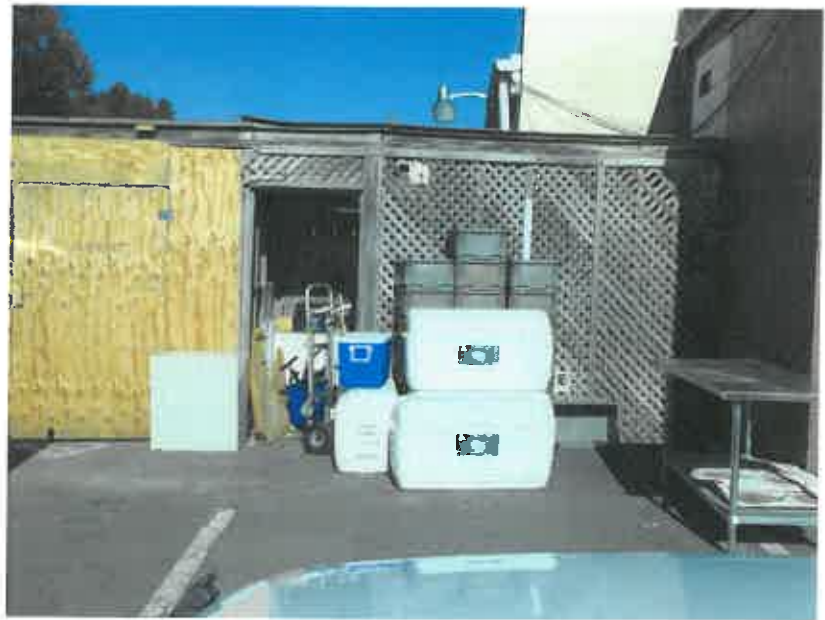
BLOCK 419 LOT 9

1. **Deterioration.** The building is dilapidated as evidenced by crumbling concrete, holes in the walls, damaged gutters, and deteriorated crumbling windows. The building appears to have not been properly maintained as illustrated in the photographs above. Additionally, the deteriorated parking area and sidewalk which have negative impacts on the public. Therefore, Statutory Criteria "a" is met.
2. **Improper layout.** The front of the site has an undefined curb cut, which allows for vehicles to back into Kinderkamack Road. Further, there exists a faulty arrangement in the rear of the site and lacks parking and the proper drive aisles. If the parking spaces are utilized, a vehicle has to back out onto the adjacent lot to exit the site. Therefore, Statutory Criteria "d" is met.

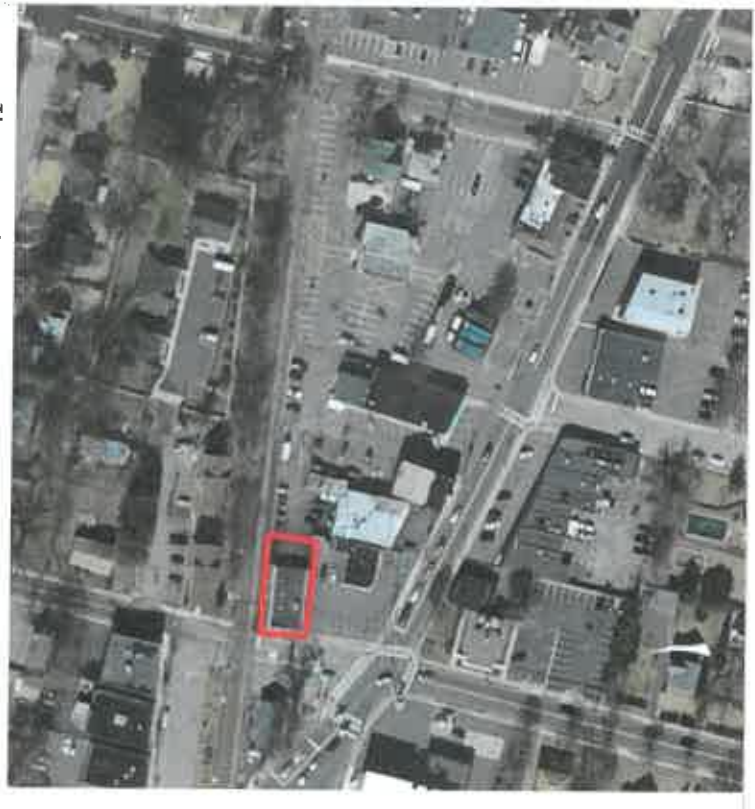
BLOCK 419 LOT 10

Description: commercial

Violations: 2007, weeds and tall grass; 2009, signage; 2009, dumpster enclosure; 2010, property maintenance; 2014, signage

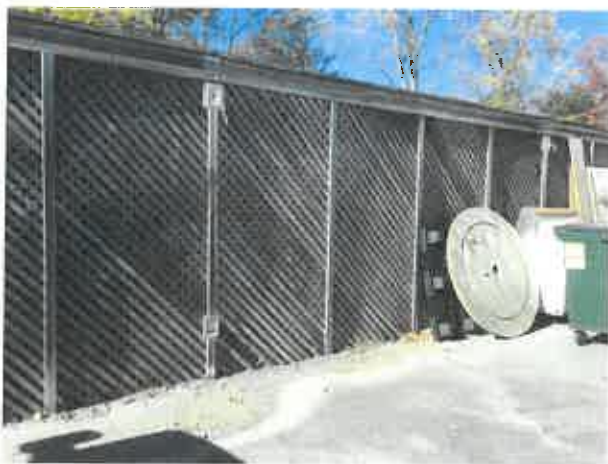
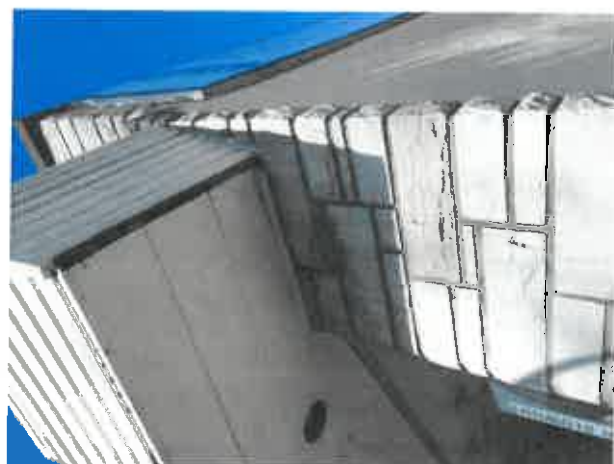
1. The site exhibits faulty arrangement that is characteristic of meeting Criteria "d". The Faulty arrangement is due to the size and location of the building on site. This creates a site with an inefficient layout with no opportunities to improve. Given the uses and building size, there is a need for outdoor storage and display. The lack of a curb cut is of typical of modern planning standards. Therefore, Statutory Criteria "d" is met.
